Focused Site Inspection Prioritization Report

Belvidere Municipal Landfill #2

USEPA ID No. ILD 000 605 113

September 10, 1995

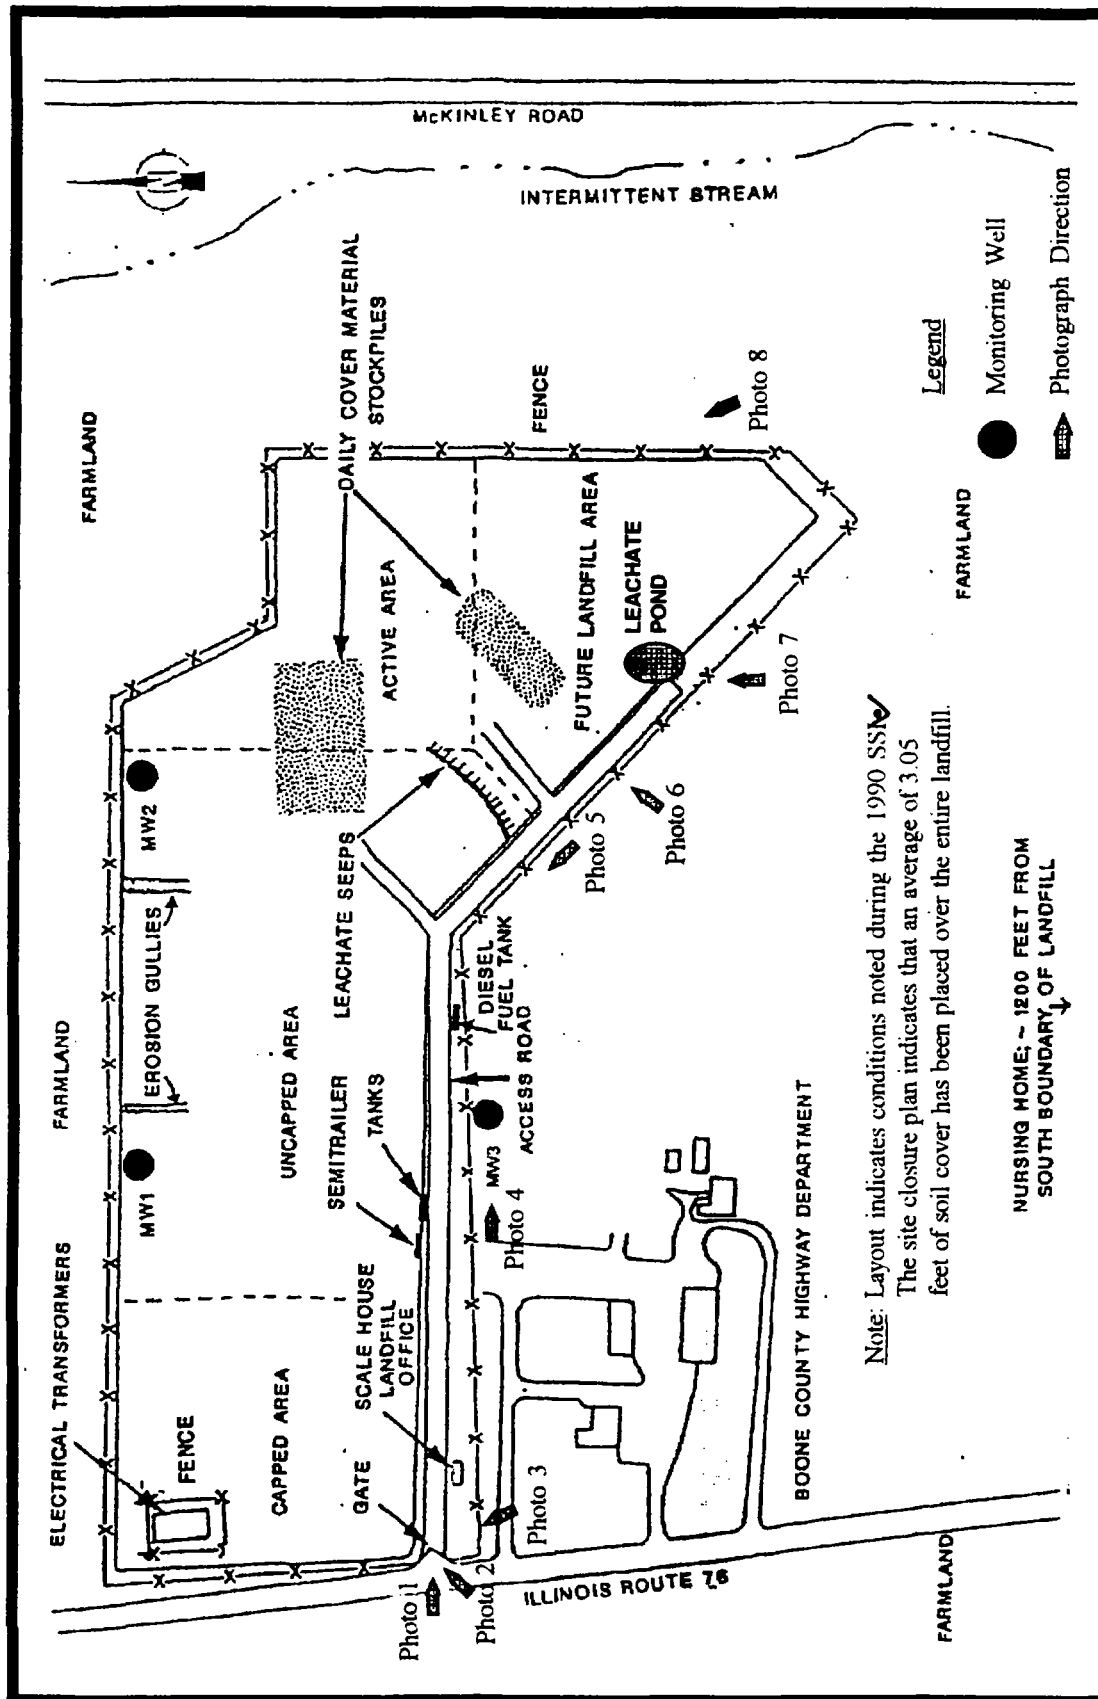
Figure 2

A leachate ponding area was seen near the end of the haul road on the southeastern portion of the landfill. The leachate had a very strong sulfur odor, but did not appear to be migrating offsite. Leachate seeps were also noted on the eastern slope of the landfill and in two locations on the northern slope of the landfill. Water was seen ponding on the northern edge of the landfill below a seep near the western corner. The water appeared to have a sheen, but had no odor. Vegetation on the landfill did not appear to be stressed. The western edge of the site was obscured by tall shrubs growing inside the fence line. A nursing home is located approximately 1,200 feet south of the landfill. Directly south of the site, the state and county highway departments have maintenance facilities on an adjacent property. Highland Memorial Funeral Home, Inc., is located west of the landfill.

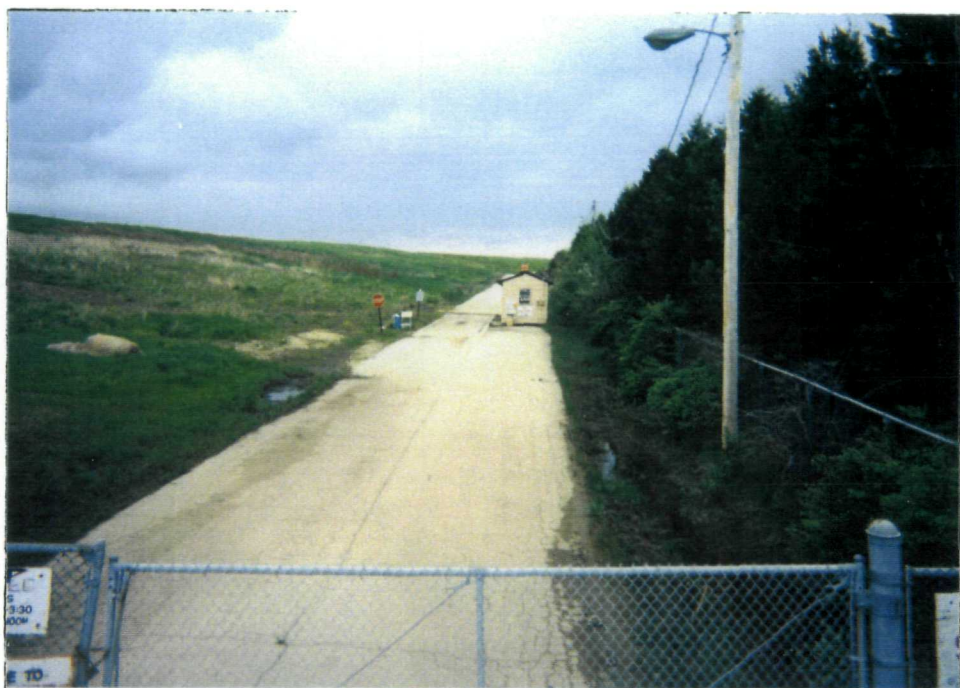
Date: May 18, 1995
Time: 0932
Photo Taken By: J. Noyes
Photo Number: 1
Site/ILD No.: Belvidere
Municipal #2/
ILD000605113
Direction of Photo: Facing
East
Description: From entrance
on I76.

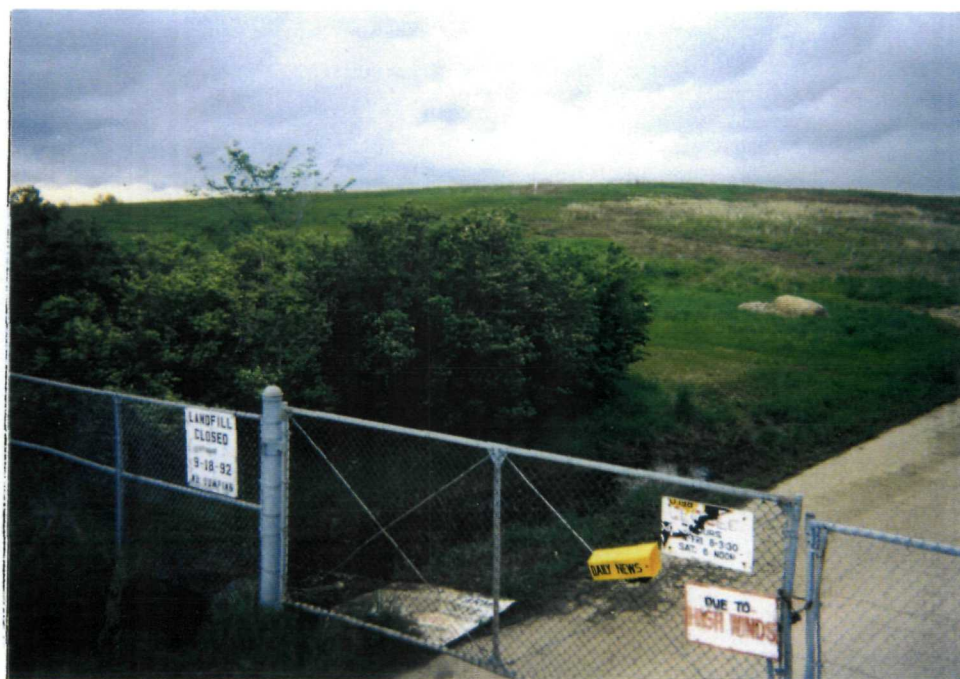
Date: May 18, 1995
Time: 0932
Photo Taken By: J. Noyes
Photo Number: 2
Site/ILD No.: Belvidere
Municipal #2/
ILD000605113
Direction of Photo: Facing
Northeast
Description: Photo of
landfill.

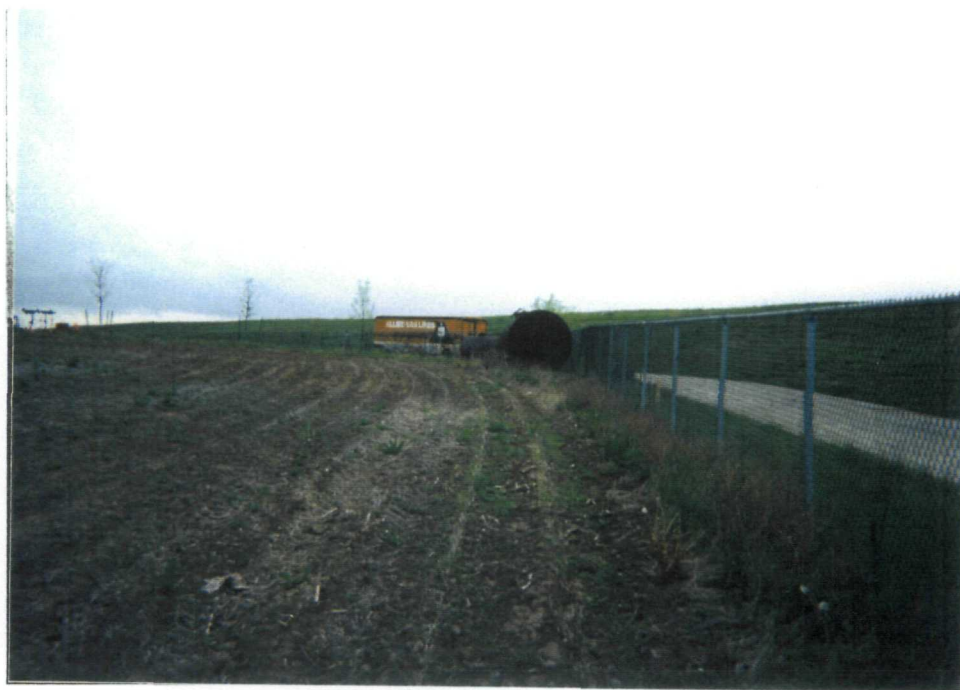
Date: May 18, 1995
Time: 0954
Photo Taken By: J. Noyes
Photo Number: 5
Site/ILD No.: Belvidere
Municipal #2/
ILD000605113
Direction of Photo: Facing
Northwest
Description: From south
center of site.

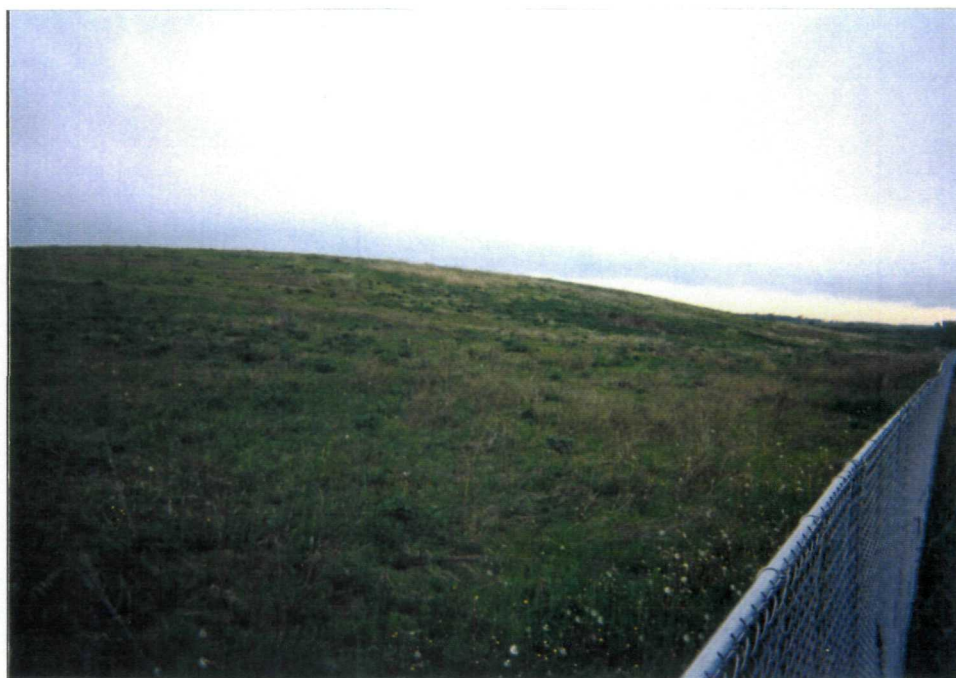
Date: May 18, 1995
Time: 1007
Photo Taken By: J. Noyes
Photo Number: 8
Site/ILD No.: Belvidere
Municipal #2/
ILD000605113
Direction of Photo: Facing
Northwest
Description: Photo of
backside of landfill.
